Significant Wear Reduction

Zimmer®
Prolong®
Highly
Crosslinked
Polyethylene

Improved polyethylene performance

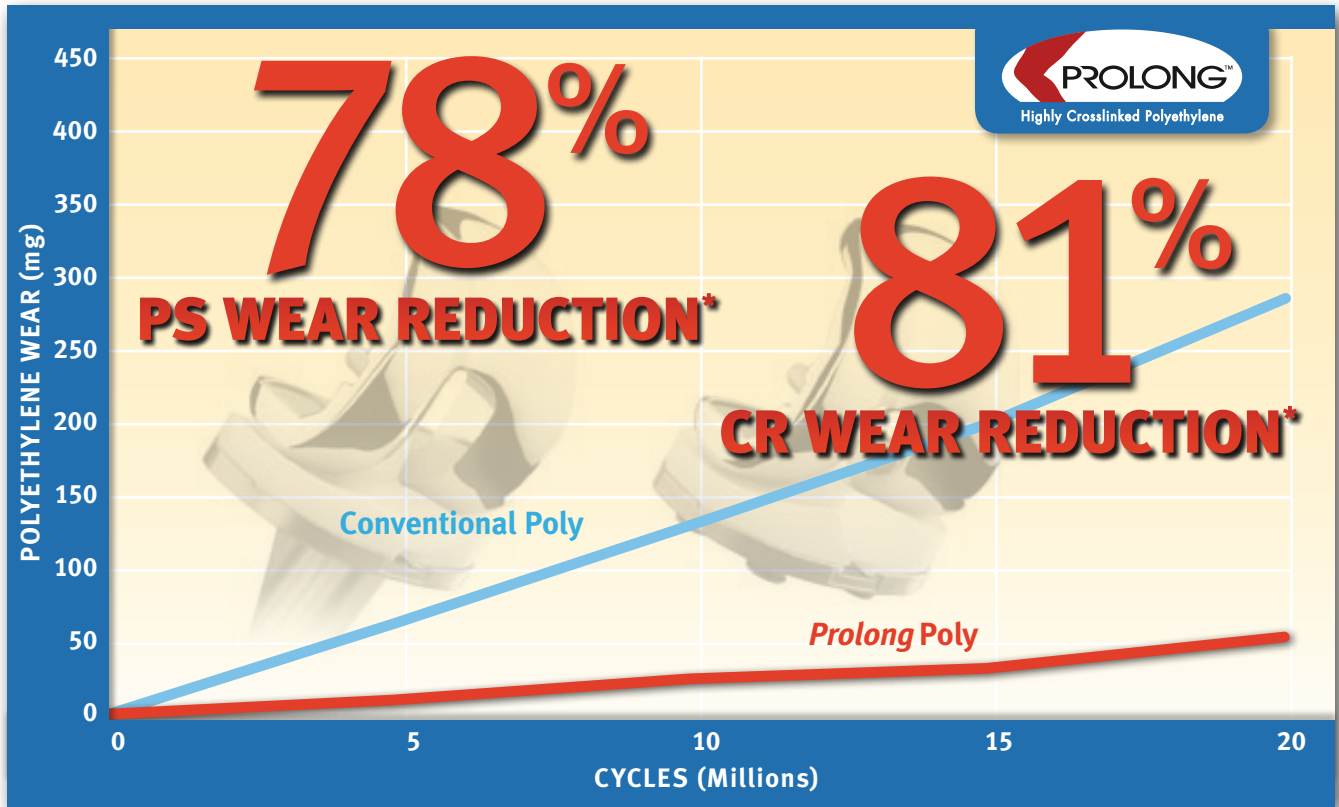
**In vitro wear simulator testing demonstrated an 81% reduction in total volumetric wear of CR articular surface components and a 78% reduction in total volumetric wear in PS articular surface components compared to conventional polyethylene. The results of in vitro wear tests have not been shown to correlate with clinical wear mechanisms.*

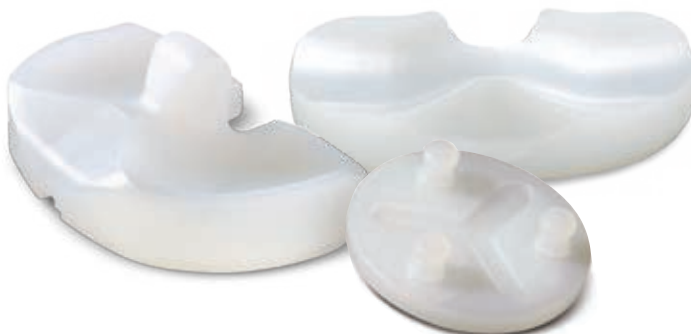
Prolong Highly Crosslinked Polyethylene is formulated specifically to resist wear under the conditions found in knees and represents a significant scientific advancement in wear reduction. In wear and damage mechanism studies, *Prolong* polyethylene consistently resisted oxidation and delamination, thereby decreasing surface wear and subsurface fatigue that can lead to delamination or pitting.⁹

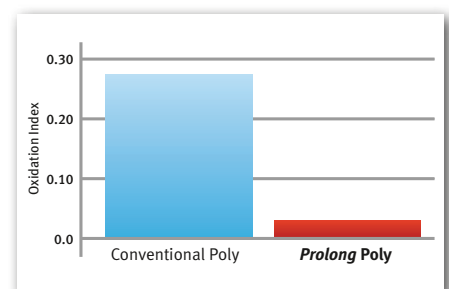
OXIDATION

In laboratory testing Prolong polyethylene effectively resisted oxidation.

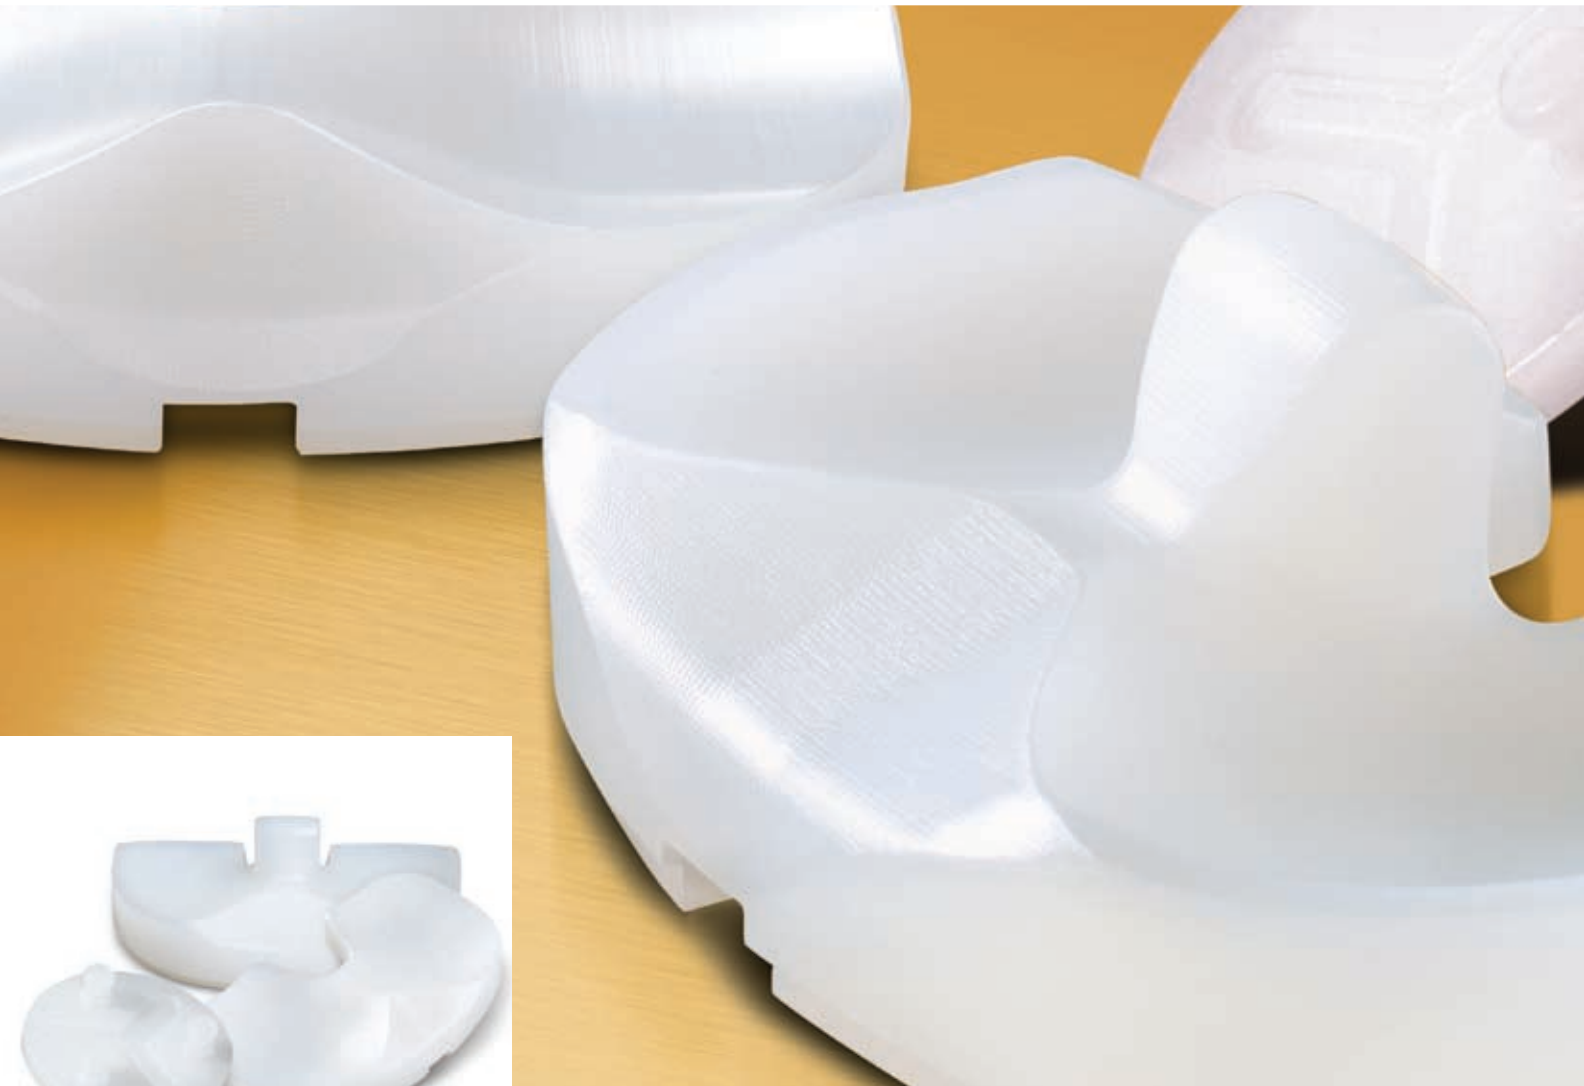
Typical wear associated with conventional polyethylene knee inserts.

While TKA has proven successful, tibial insert wear and damage are often cited as primary causes for an estimated 63,000 revision knee surgeries each year.^{1,2,3,4} One recent study identified polyethylene wear as the most common cause for knee revisions.⁵ In this study, 44% of knees revised more than two years after the index arthroplasty were directly attributed to polyethylene wear.

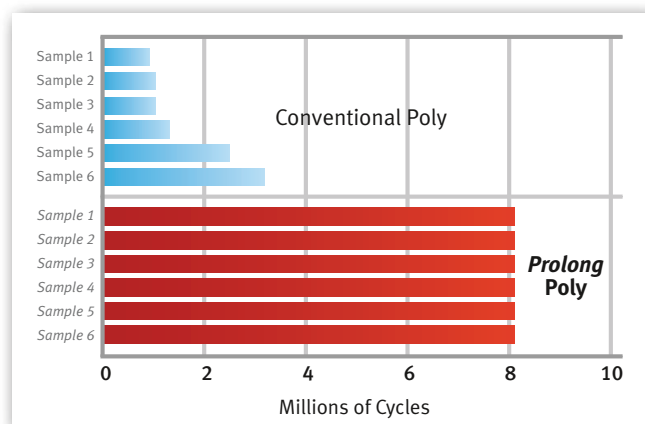
START OF DELAMINATION IN LABORATORY TEST SAMPLES

In head-to-head testing specifically designed to result in early onset of delamination, conventional polyethylene inserts repeatedly showed signs of delamination, as compared to Prolong polyethylene, which showed no evidence of delamination.

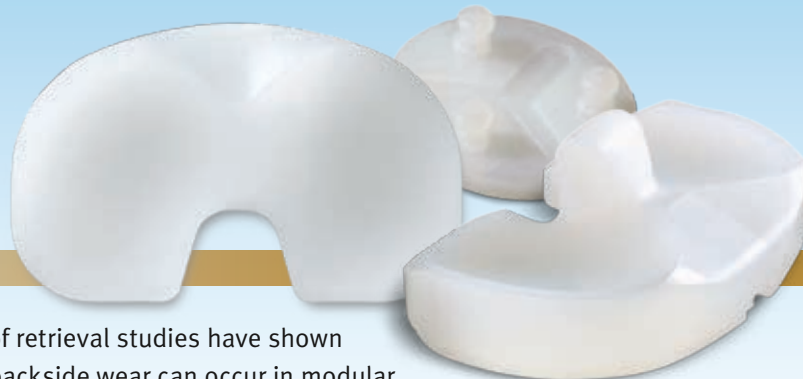
Rigorous laboratory delamination testing conducted at Zimmer demonstrated no delamination in any *Prolong* samples up to 8 million cycles.¹

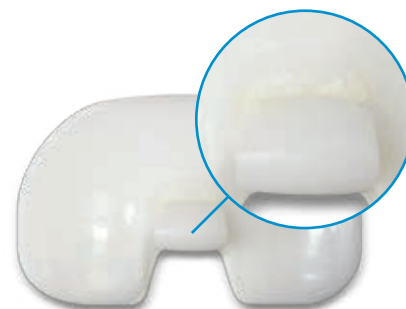
Delamination pattern shown on PS post of conventional polyethylene test sample. No delamination occurred on the Prolong polyethylene post test samples.

In vitro wear and PS post fatigue strength were compared for both conventional polyethylene and *Prolong* polyethylene.¹ In wear simulator testing, the majority of conventional polyethylene samples showed some evidence of delamination at the anterior post by five million cycles. The *Prolong* polyethylene samples exhibited no delamination.
