Zimmer®
Prolong®
Highly
Crosslinked
Polyethylene

Improved polyethylene performance

Why Prolong Highly Crosslinked Polyethylene...

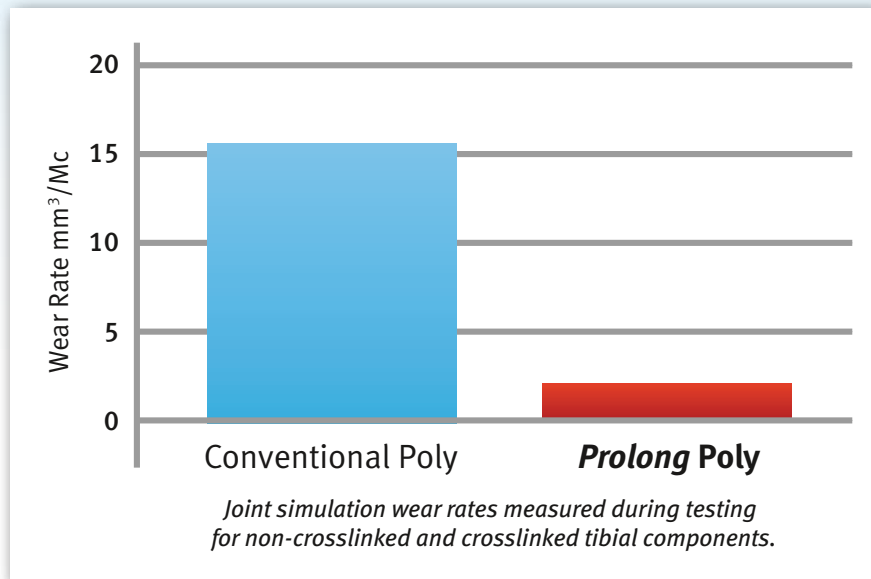
WEAR RATES

In laboratory testing, conventional polyethylene components exhibited almost 8x more wear than the Prolong polyethylene samples.

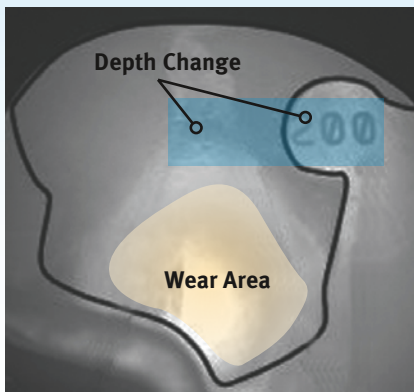
The reduced thickness of conventional polyethylene by backside wear is indicated by the depth change of engraved numbers and the burnished wear of the central, load-bearing section. Conversely, Prolong polyethylene effectively minimizes backside wear.¹¹

A number of retrieval studies have shown that tibial backside wear can occur in modular knee designs using conventional polyethylene inserts.^{12,13,14} Relative micro-motion between the tibial insert and base plate, for example, can produce backside wear in modular tibial components.¹¹ In laboratory testing, *Prolong* polyethylene demonstrated a marked reduction in backside wear versus conventional polyethylene.⁸

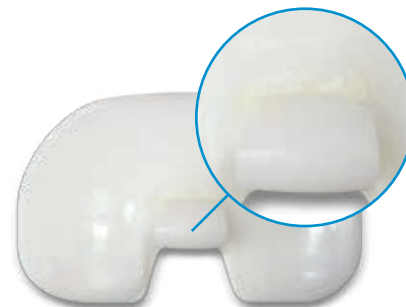
Delamination pattern shown on PS post of conventional polyethylene test sample. No delamination occurred on the Prolong polyethylene post test samples.

In vitro wear and PS post fatigue strength were compared for both conventional polyethylene and *Prolong* polyethylene.¹ In wear simulator testing, the majority of conventional polyethylene samples showed some evidence of delamination at the anterior post by five million cycles. The *Prolong* polyethylene samples exhibited no delamination.
